THE UNITED STATES  
STRATEGIC BOMBING SURVEY

# THE ELECTRIC POWER INDUSTRY OF JAPAN

(Plant Reports)

Electric Power Division

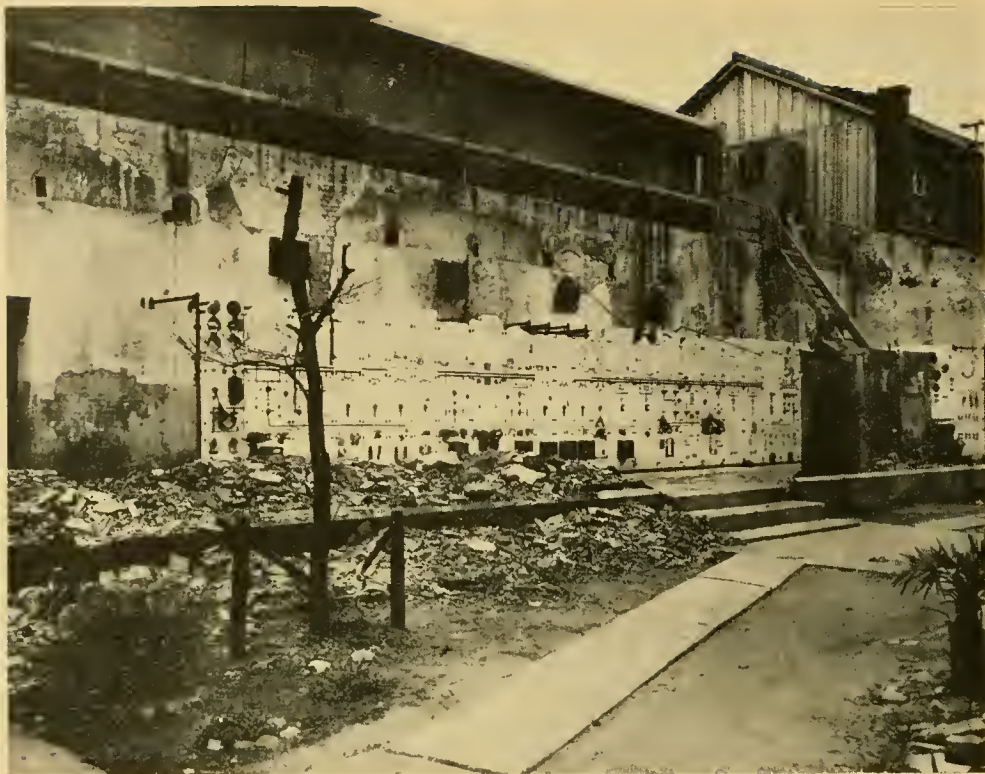
Photo 17—Rokugo—Remains of control board

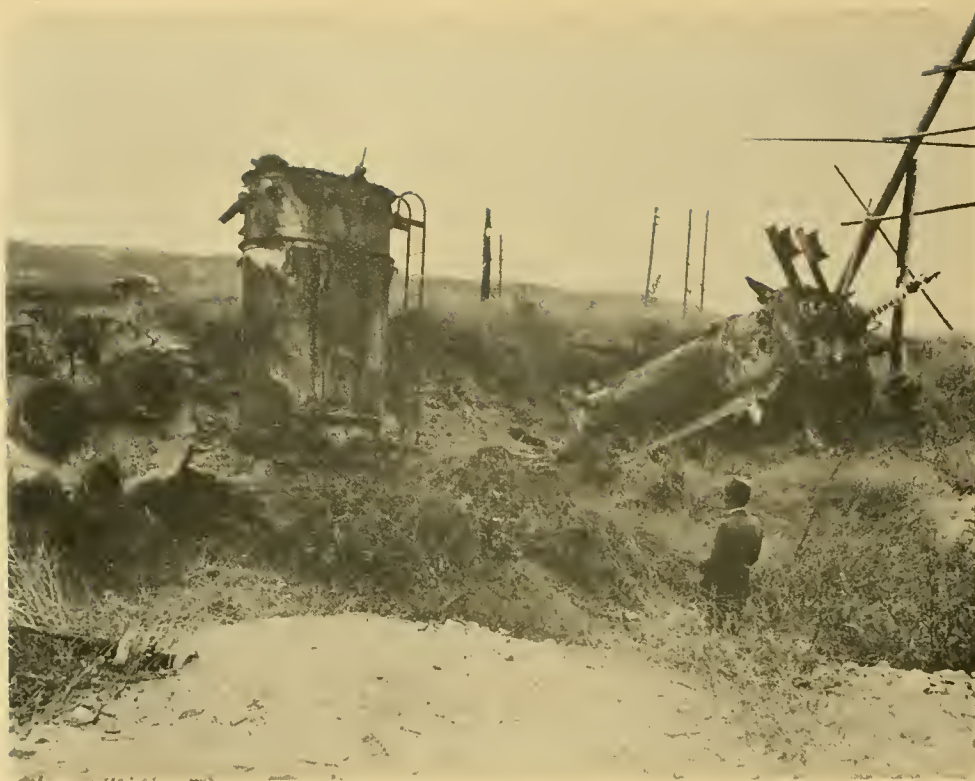
Photo 21—Taiko—Transformer bank of 3—10000-KVA transformers completely destroyed by direct hit and fire

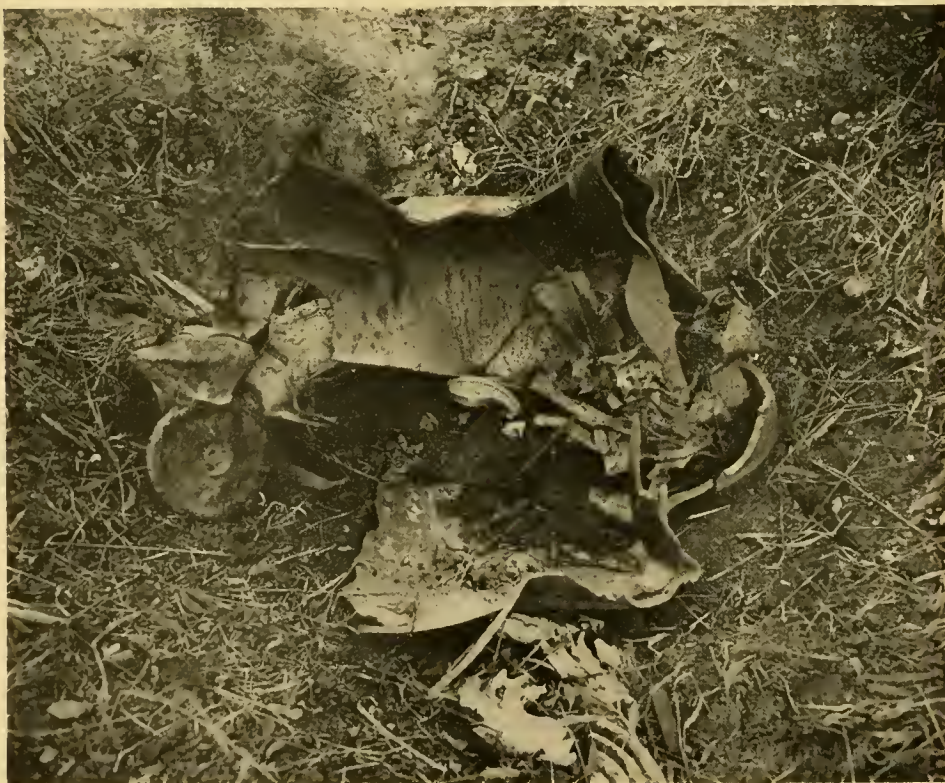
Photo 26—Taiko—Casing of 500 lb bomb found in bottom of crater at station

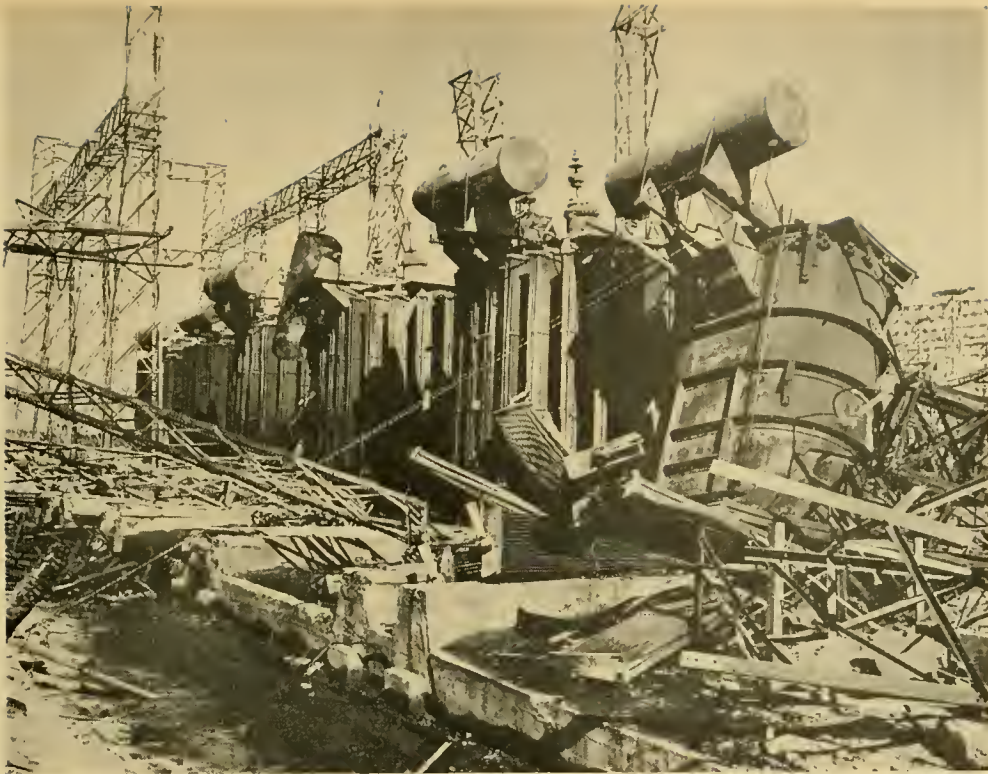
Photo 3—Bank of 6 damaged transformers

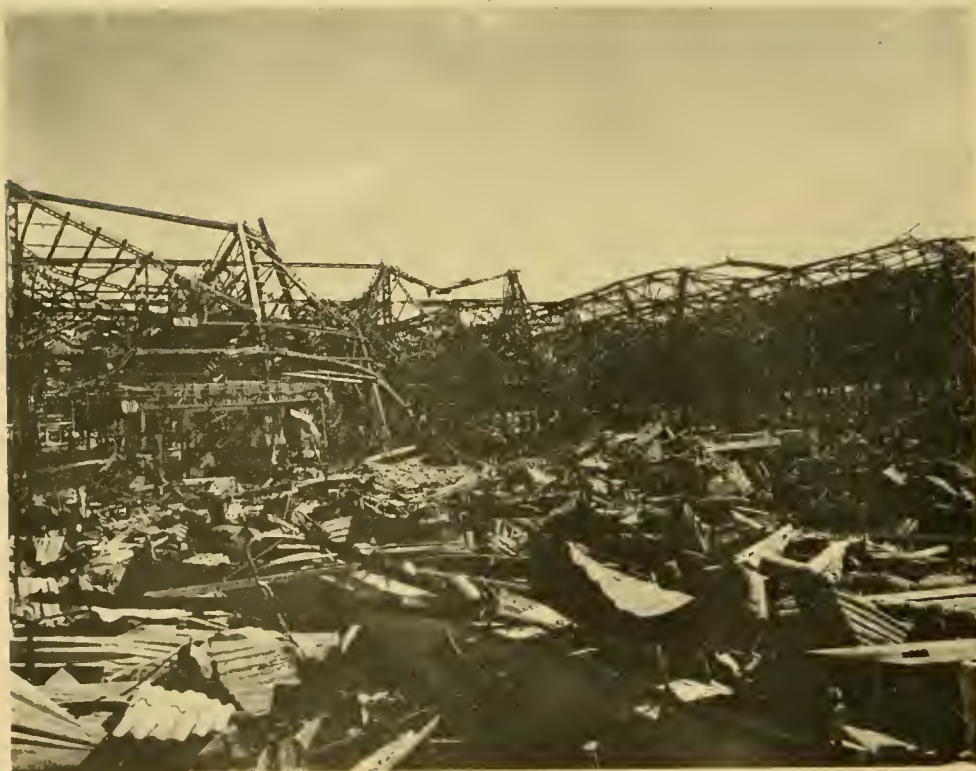
Photo 6—View of damaged manufacturing building near Sakurajima substation

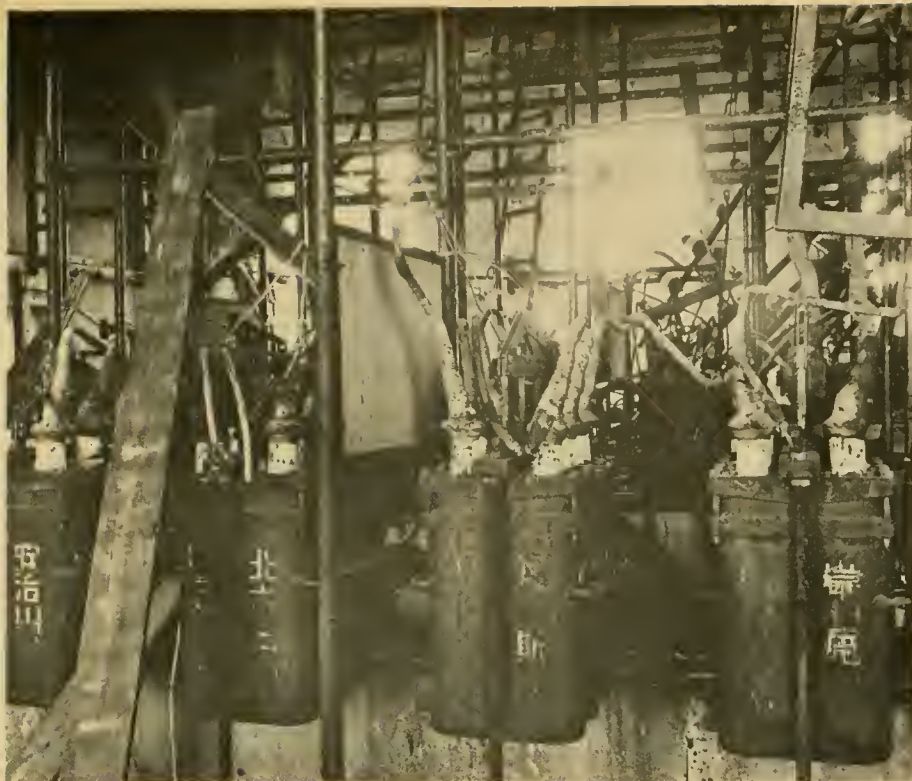
Photo 7—Sakaigawa substation, damaged 3-KV switching

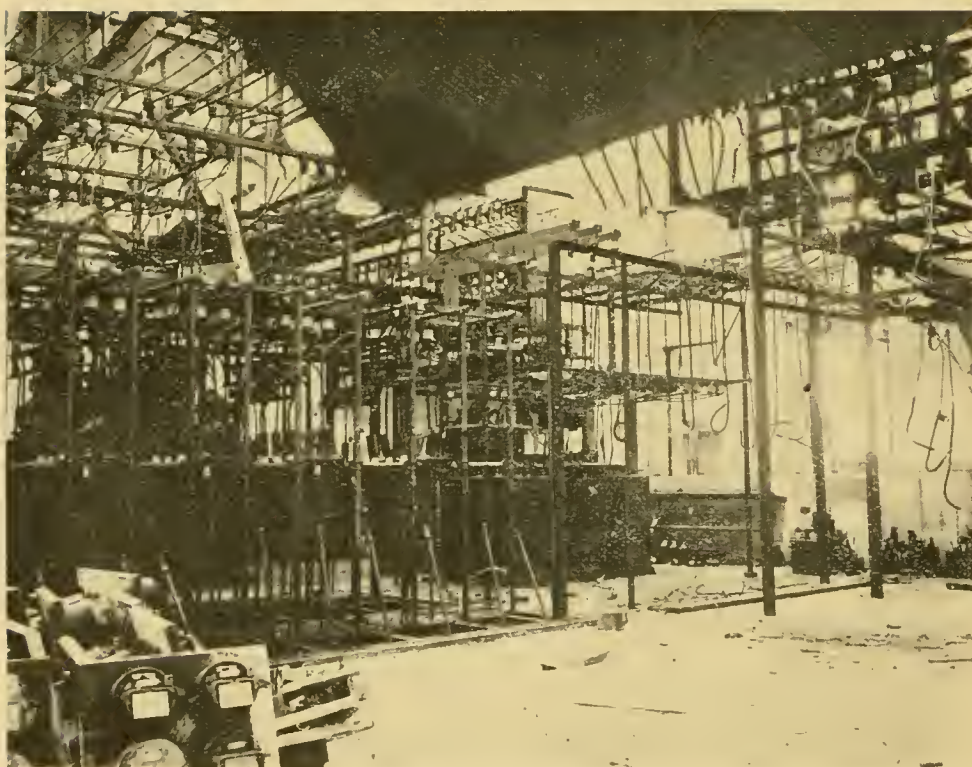
Photo 10—Ishizugawa substation-view showing location of damaged control board in front of damaged 3-KV switch gear

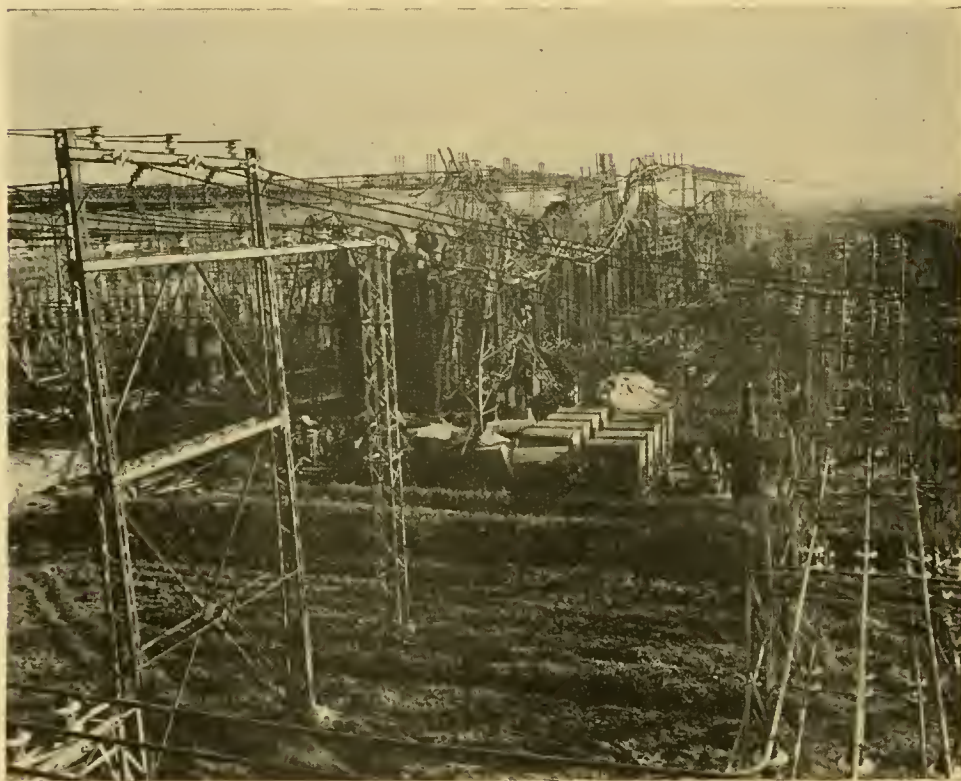
Photo 1—General view of main damaged section, looking south from control room

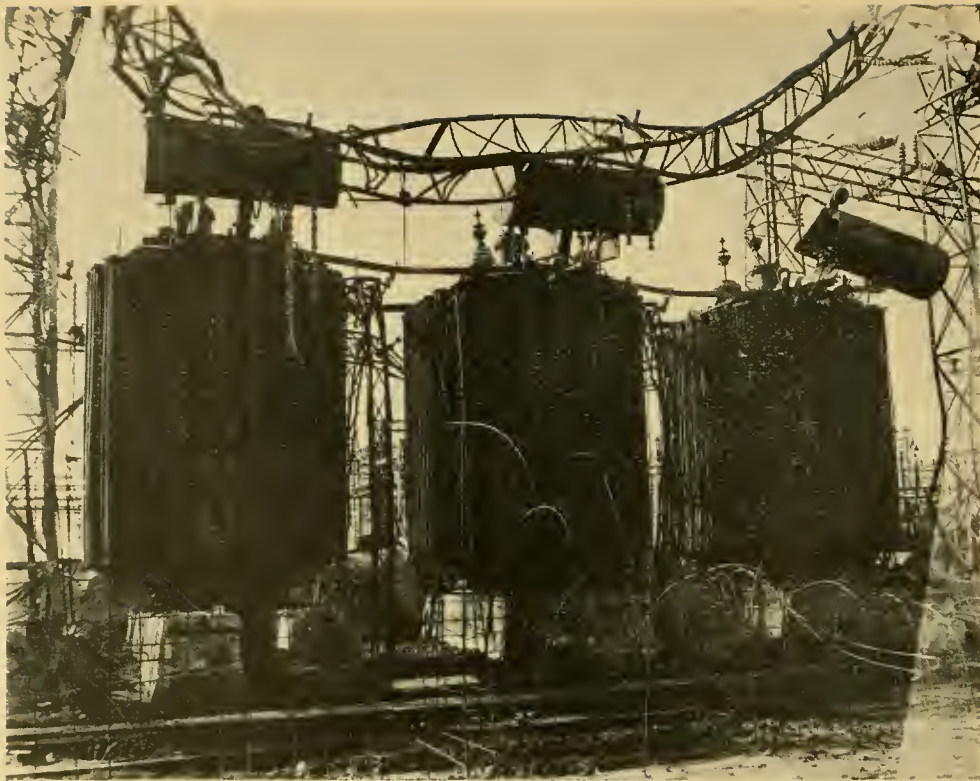
Photo 3—Another view of nearest bank shown in photo 2—reinforcing rods for protective wall in foreground

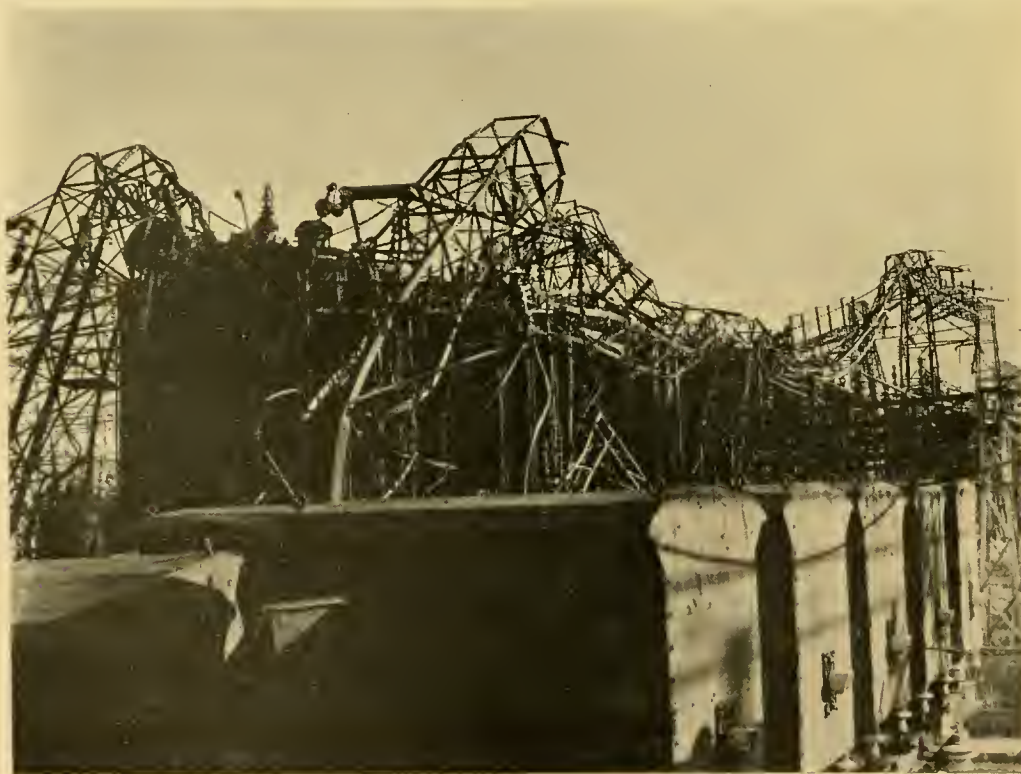
Photo 4—Another view of damaged transformers and structure, with outdoor grounding resistors in foreground

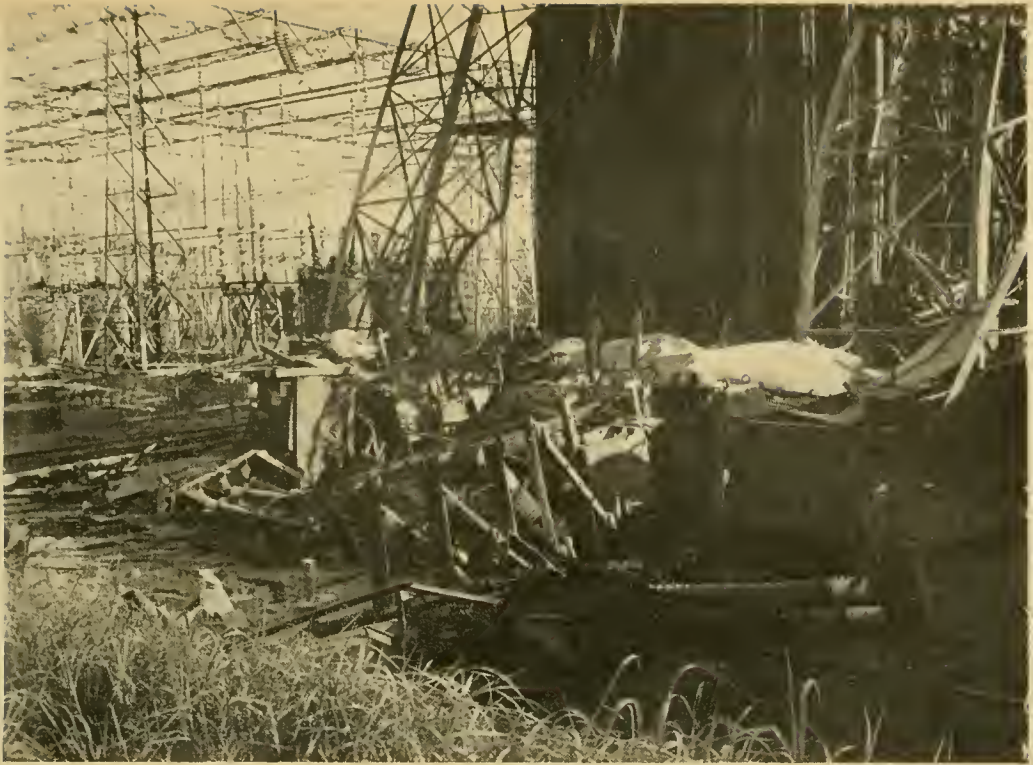
Photo 5—Closer view of damaged grounding resistors

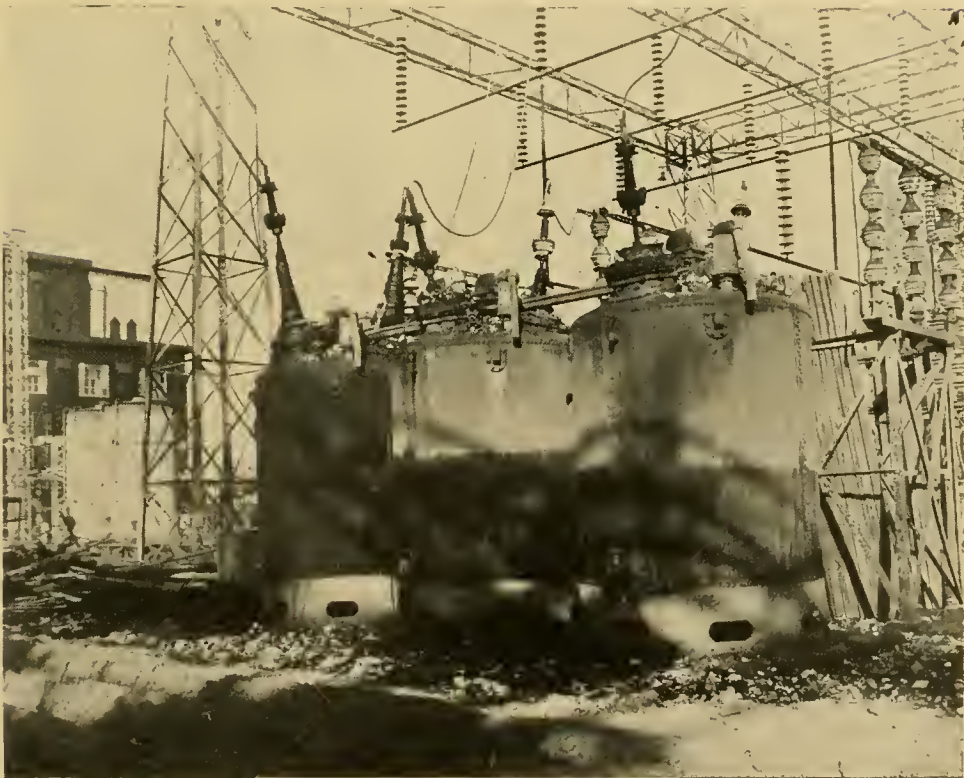
Photo 6—View showing damaged 140-KV oil circuit breaker for transformer bank No 1, with east end of synchronous condenser building at left

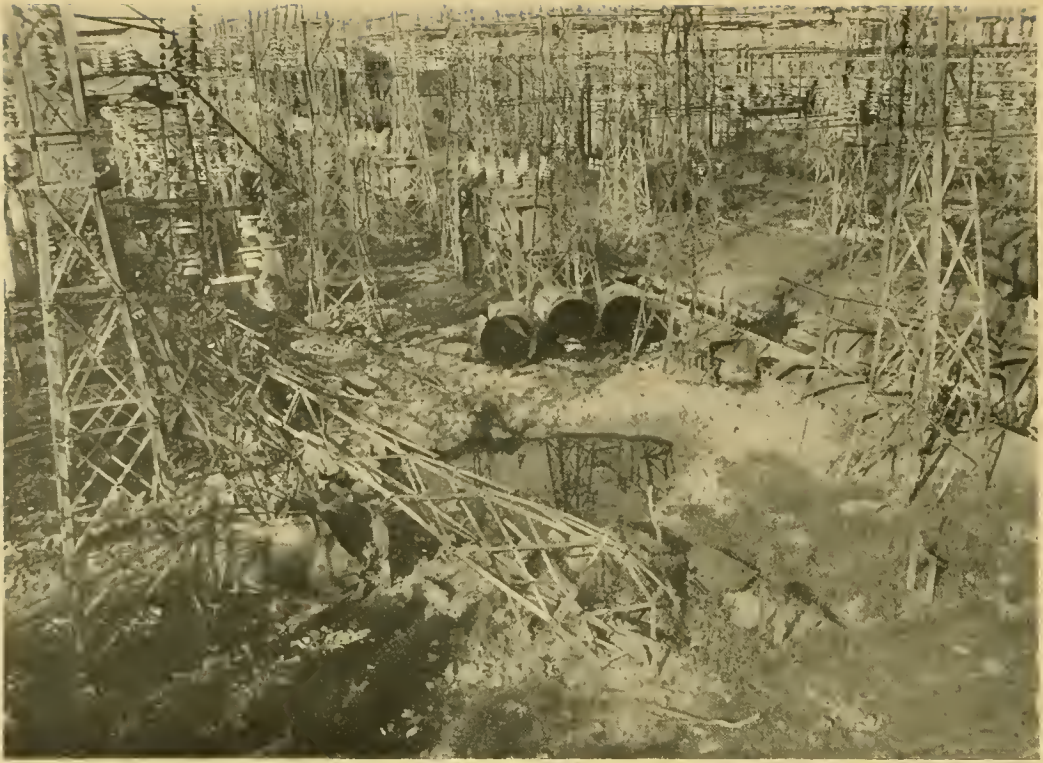
Photo 7—View showing damage done by rocket hit in 77-KV switching section

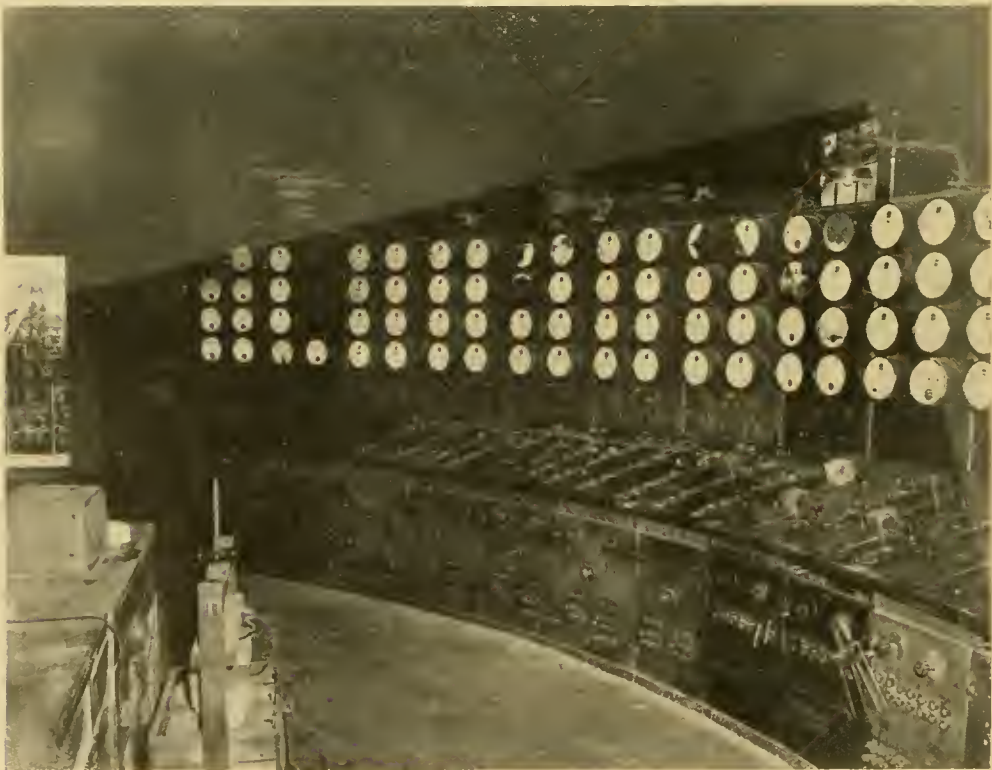
Photo 8—View of partially repaired control desk

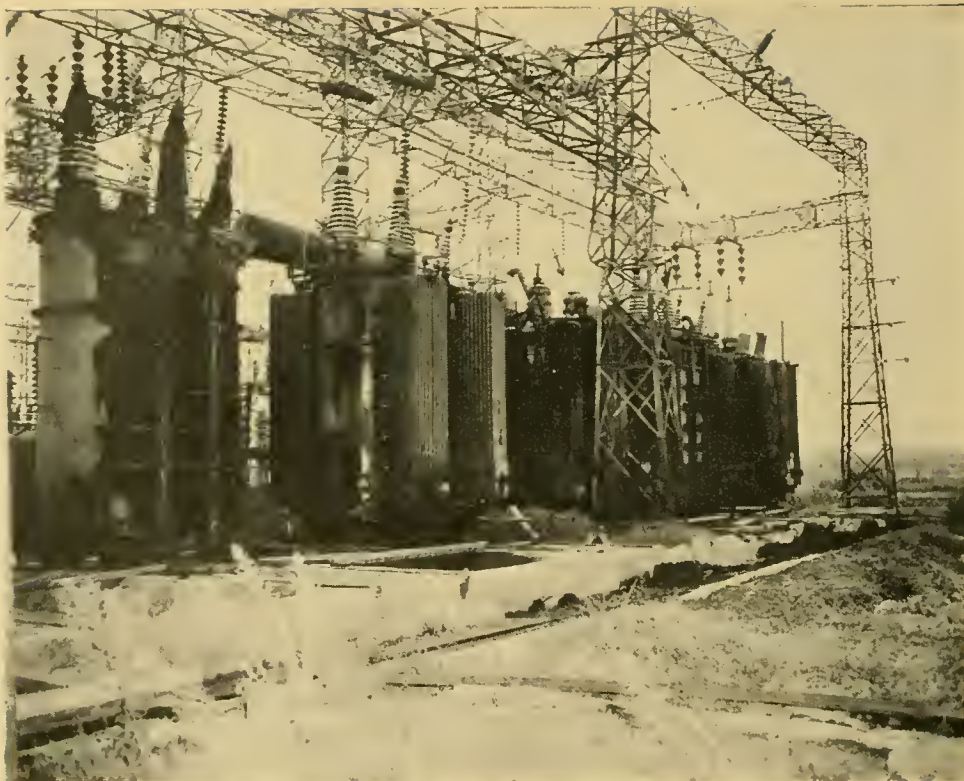
Photo 1—60,000-KVA transformer banks, showing transformer positions from left to right, numbered 2 through 6 (No 1 transformer not shown on left). Damaged transformers were originally in positions 4, 5 and 6; now occupy positions 2, 4, and 6

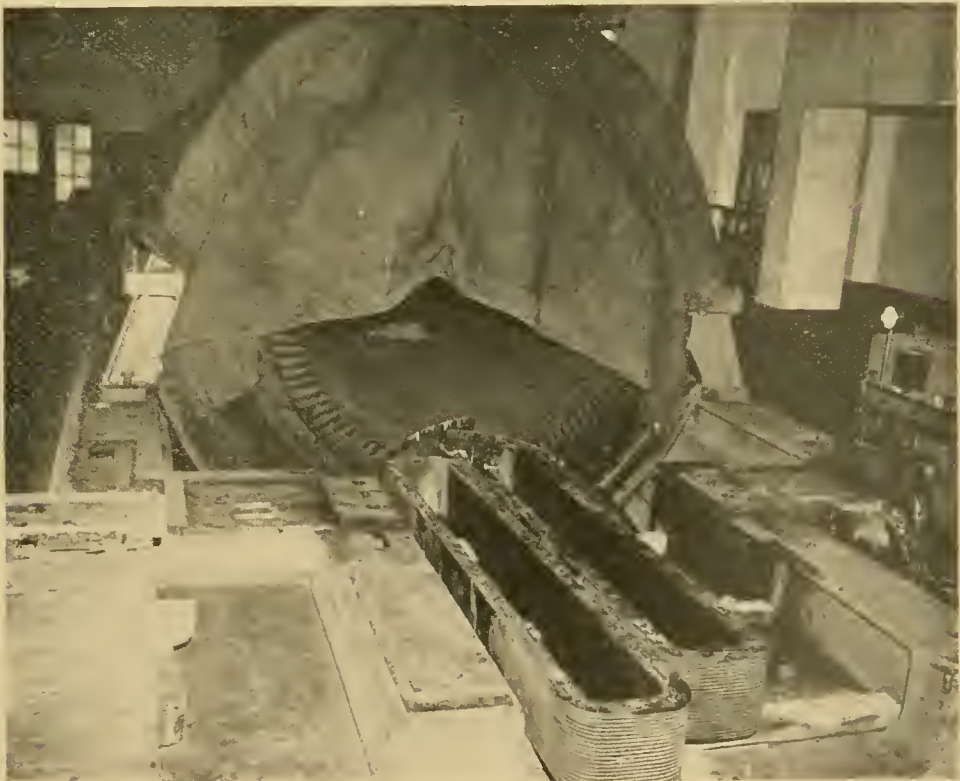
Photo 17—Hatogaya substation—30,000-KVA Mitsubishi condenser out of service because of burned out field coils (not as a result of bomb damage.)

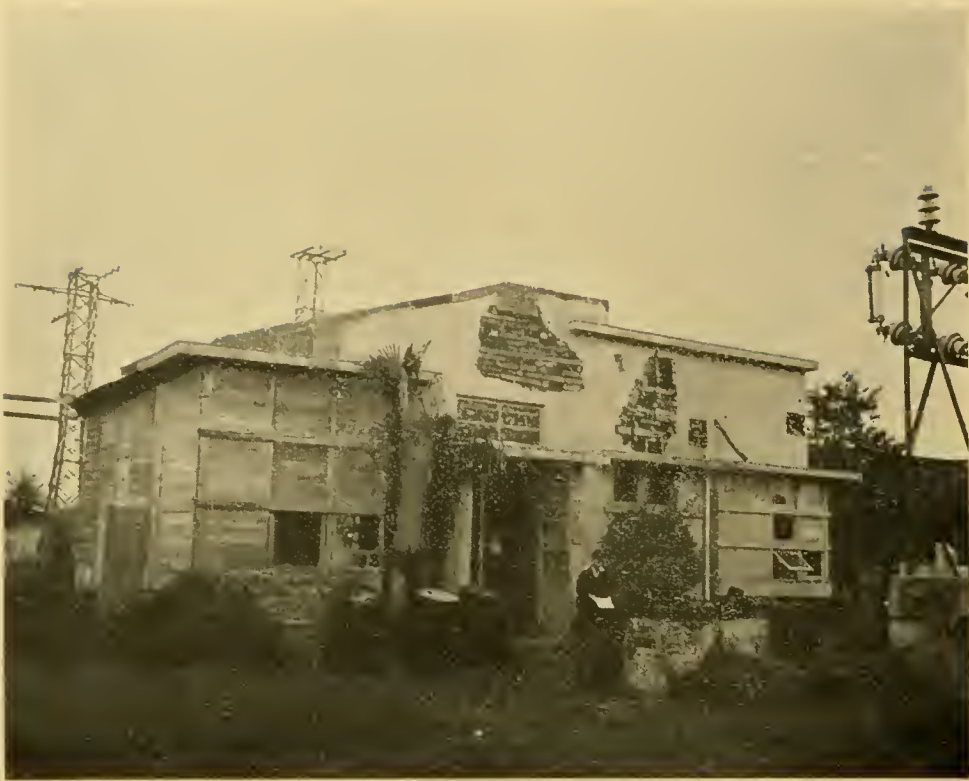
Photo 1—Chigasaki substation—front view of building showing 50-cal penetration. The building on front left is temporary new building. Bomb shelter in left foreground

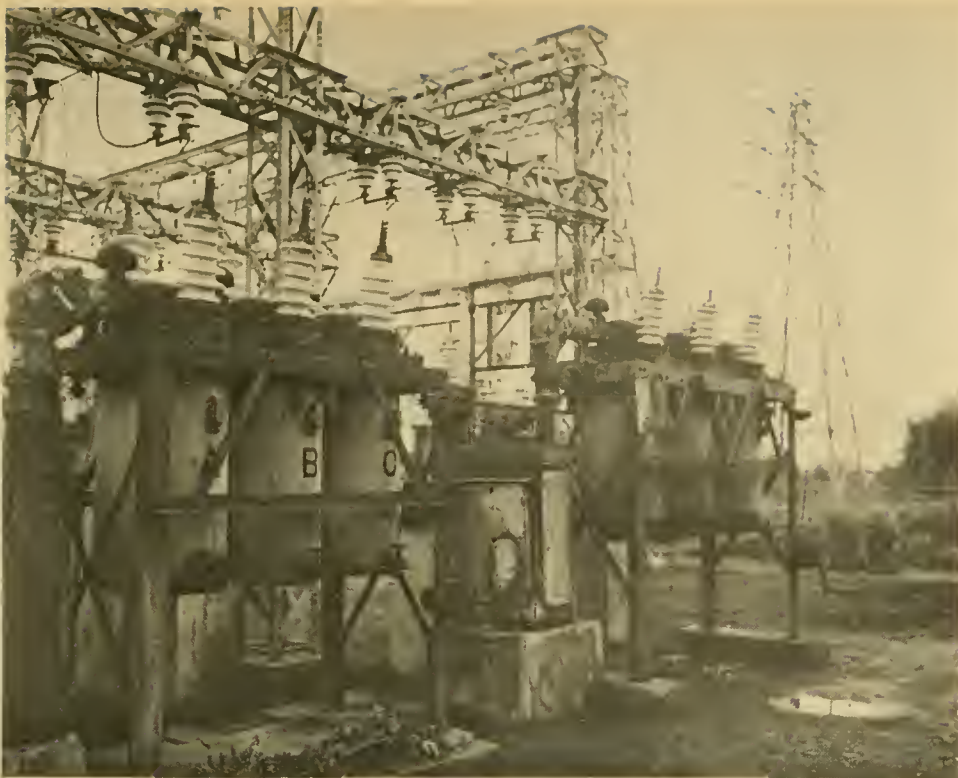
Photo 7—Chigasaki substation—22-KV OCB damaged by fire

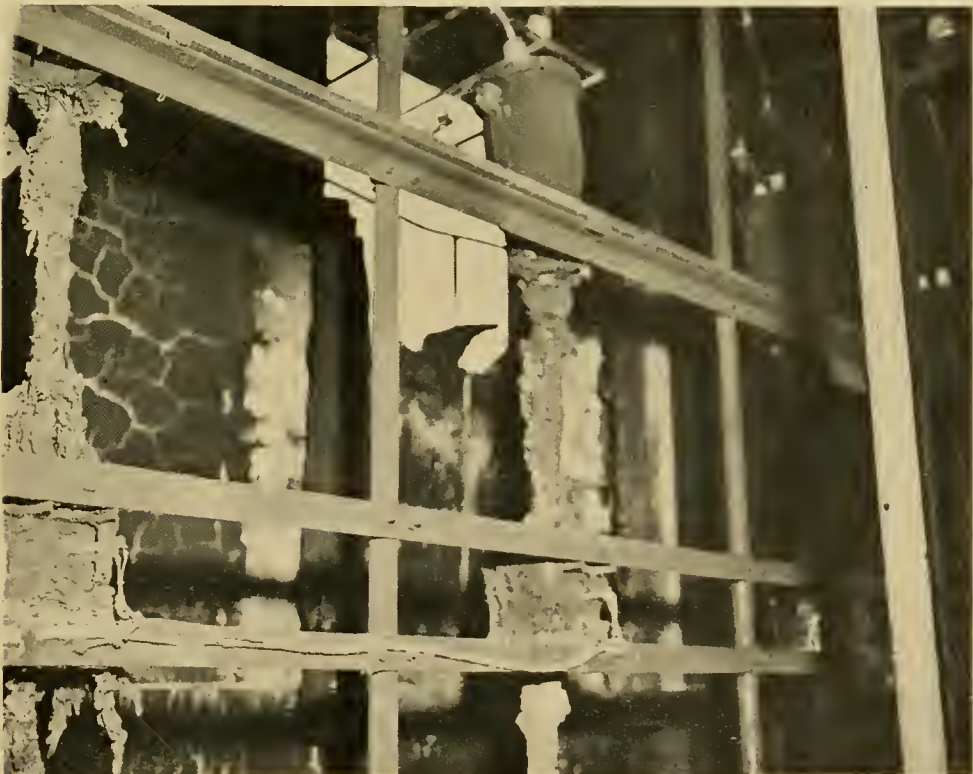
Photo 15—Kojimachi substation—Wooden blast barriers over windows burned and damaged cable entrances

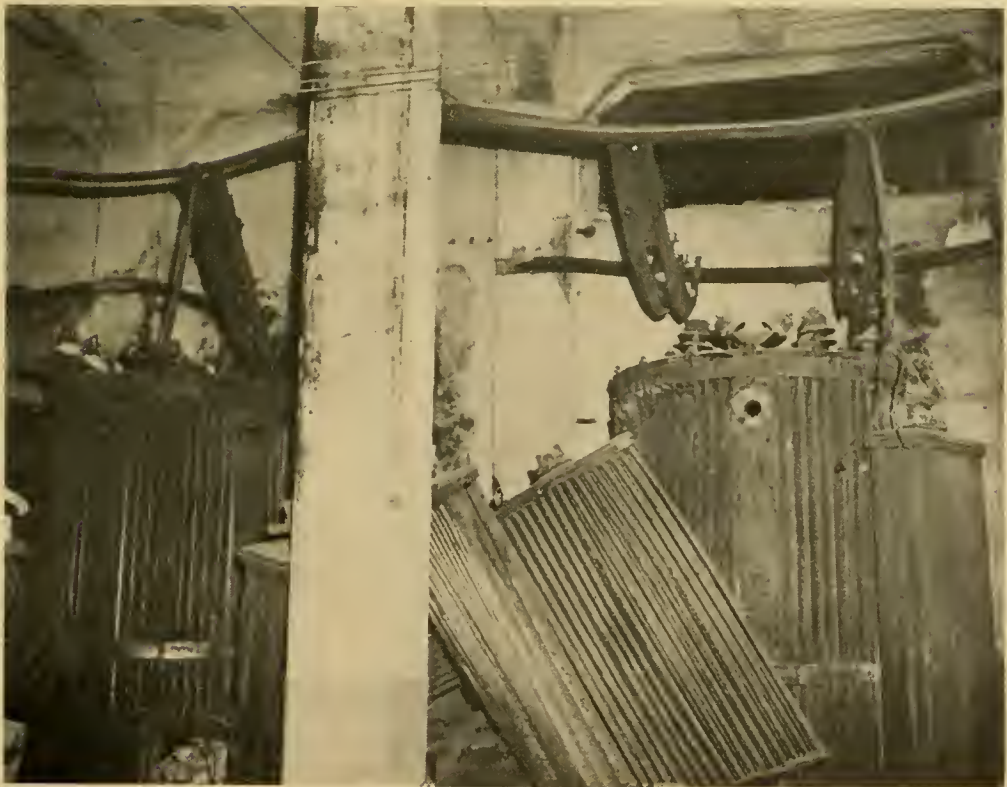
Photo 19—Kojimachi substation—Additional view of transformer damage
